# Toolbox Lifting Incidents

## Heavy Load Dropped onto Vessel.

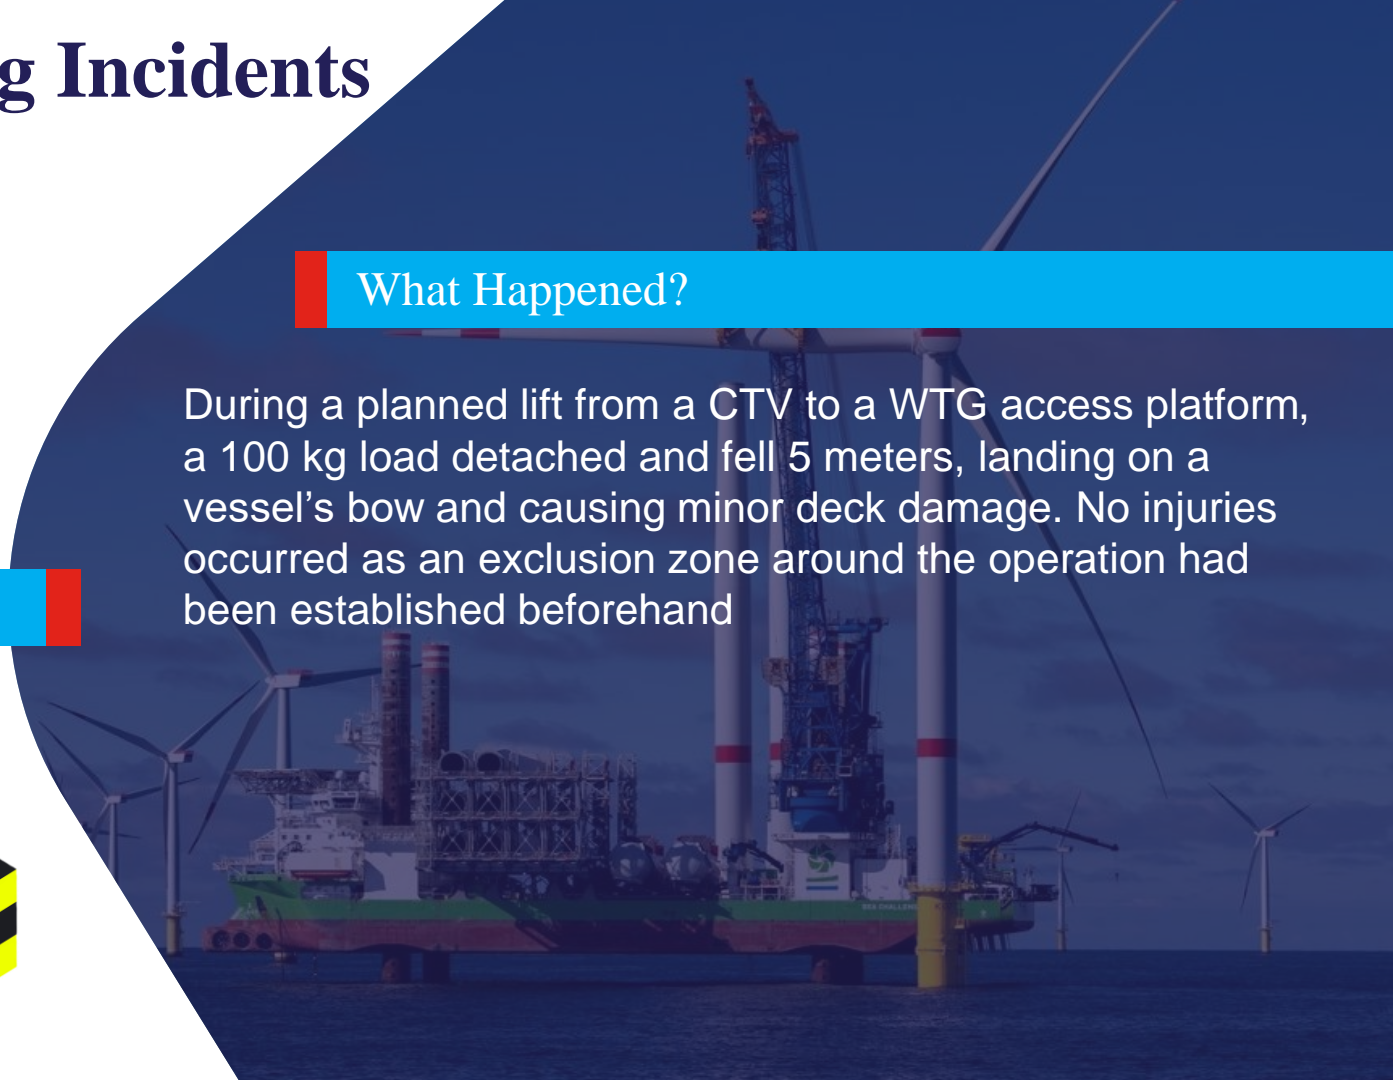
During a planned lift from a CTV to a WTG access platform, a 100 kg load detached and fell 5 meters, landing on a vessel's bow and causing minor deck damage. No injuries occurred as an exclusion zone around the operation had been established beforehand

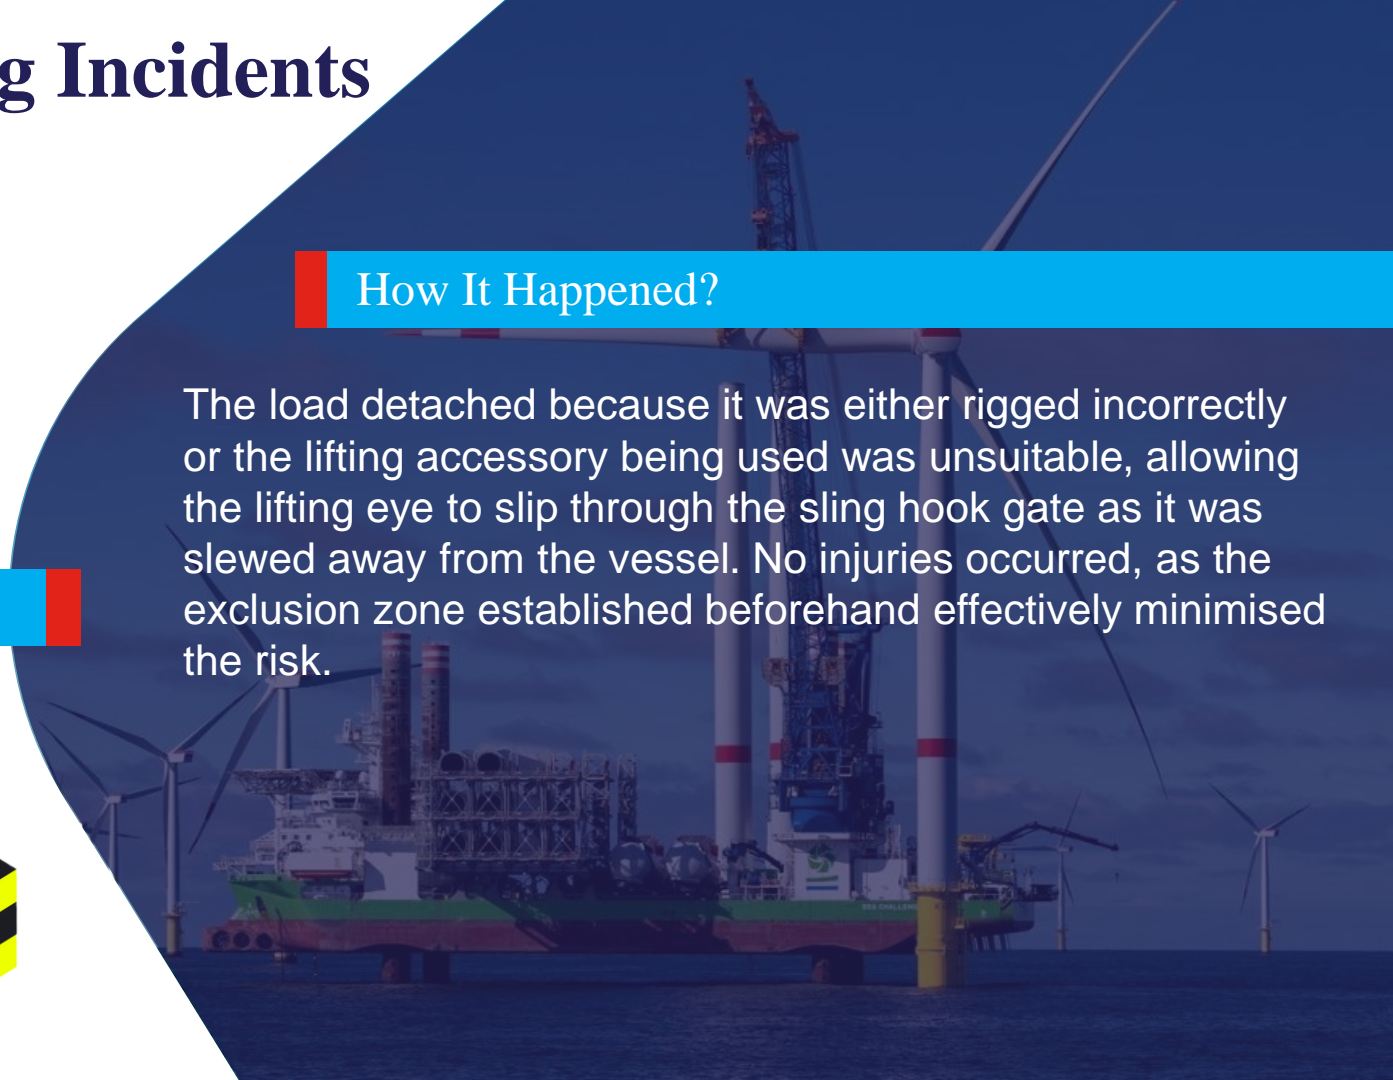
The load detached because it was either rigged incorrectly or the lifting accessory being used was unsuitable, allowing the lifting eye to slip through the sling hook gate as it was slewed away from the vessel. No injuries occurred, as the exclusion zone established beforehand effectively minimised the risk.
