Lifting Operations Incident Case Study

Vattenfall BA Wind

Incident summary

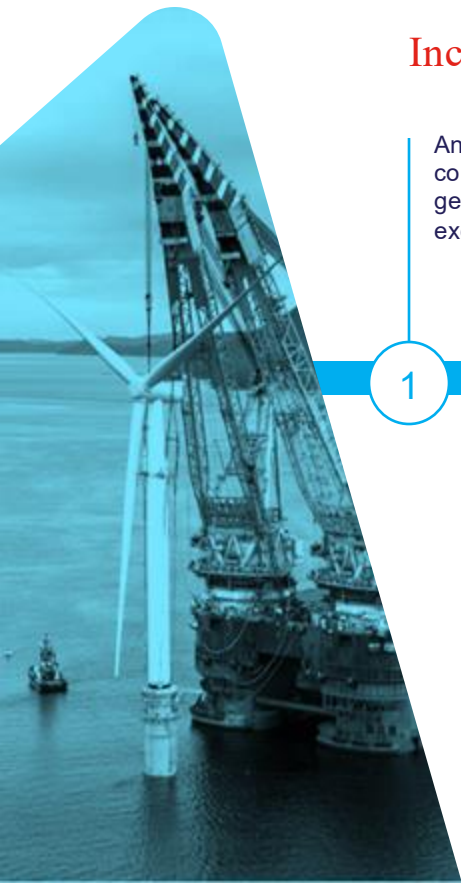
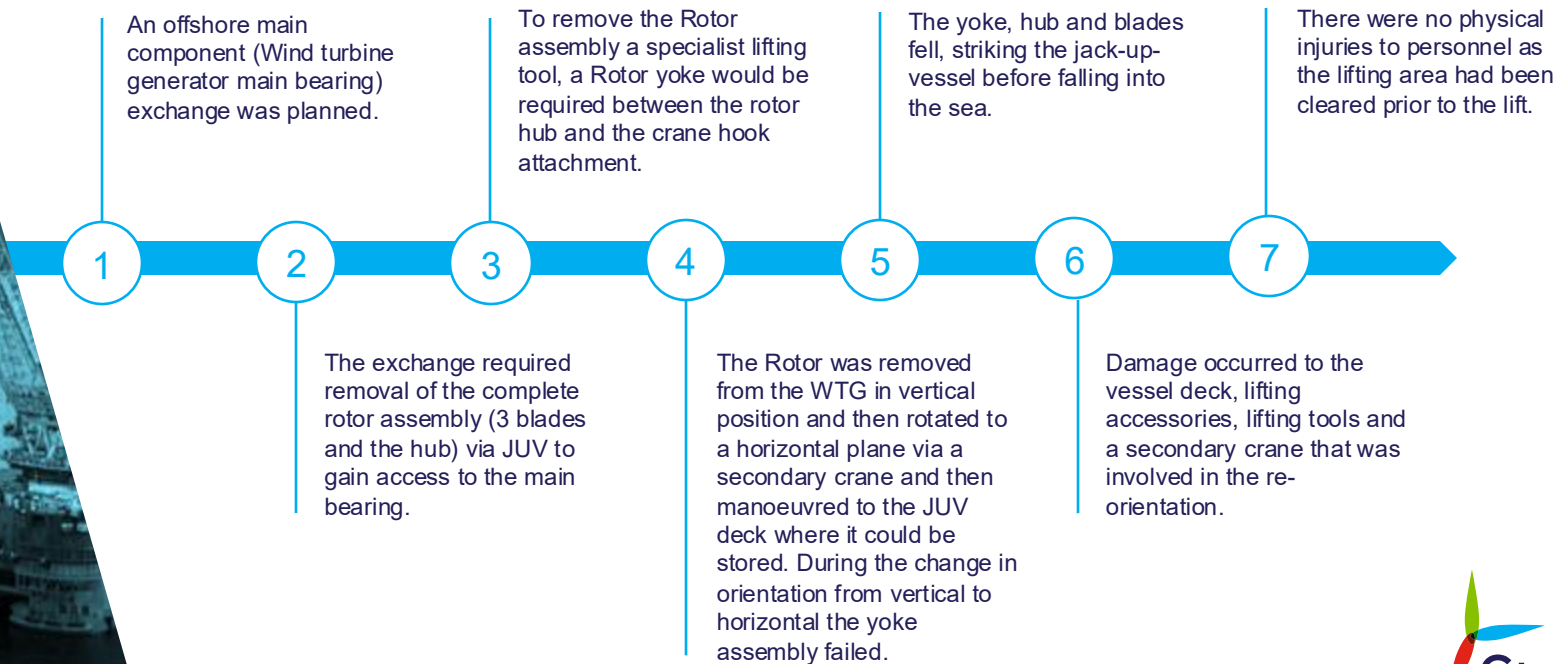
The investigations identified that the lifting system failed at the bolted connection of the yoke due to forces above its design and build specification.

These forces were applied due to the blade clamp attached to the 6 O'clock blade via the secondary crane being off-centre due to the curvature of the blade, and as the rotation of the load was ongoing this caused the rotor assembly to tilt.

The yoke had a max tolerance for side loading of 6°.

The conclusion is that execution of the lifting operation exceeded the limitations of the lifting equipment.
