Description of incident

Global Offshore Wind Ilth & Safety anisation

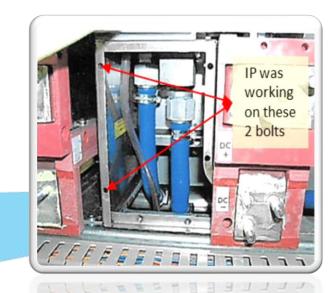
- A technician was working on changing a delta module offshore.
- One of the bolts that held the delta module in place was very tight.
- In the attempt to loosen the bolt, the injured person (IP) used excessive force and during this movement felt pain to his back.
- This procedure had been performed during previous works with no incidents reported.

- The task involved twisting, bending and stretching
- Incorrect posture when performing the task.
- IP placed his body under excessive strain to loosen the bolt

- Review method statement
- Review tools used for this scope of works, are they suitable and sufficient.
- Review toolbox talk to ensure that technicians are aware that the task could possibly lead to awkward working positions
