Safety alert: CTV contacted wind turbine causing damage to propulsion buckets

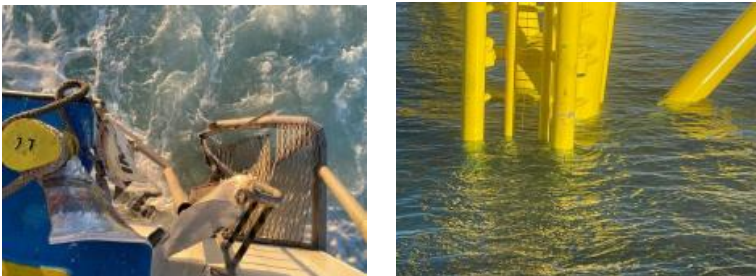
- A CTV was pushed on to the Walk to Work vessel (W2W), for transfer of PAX.
- After transfer was completed, the CTV departed from W2W and proceeded to come astern, during this manoeuvre the CTV impacted with wind turbine (WT) boat landing at approximately 5kts.
- At the time of the incident no injuries were sustained to crew or the 5 x passengers.

Port bucket damage outboard and impact area

- The CTV pushed onto W2W when the gap between WT and W2W was insufficient to carry out a safe manoeuvre of this type;
- The CTV Chief Mate failed to inform the W2W Day Captain to provide a greater separation between WT and W2W for the personnel transfer;
- W2W Captain provided a green light for the push on and PAX transfer.
- The CTV departed the W2W after PAX transfer. The Chief Mate and Watchkeeper failed to observe WT, they were unaware WT was astern of the CTV.

- PAX transfers must be pre-planned and safe distances agreed and executed prior to transfer between W2W and CTV Bridge Teams.
- Crew Transfer Procedure has been revised to illustrate correct vessel headings and safe distancing required for PAX transfer.
- Where vision is obscured, during manoeuvring of the CTV, Watchkeeper's must place themselves in such a position that they can have clear line of site of the sail route and communicate distances and positions of structures to the Vessel Master or Chief Mate whilst manoeuvring the CTV.
- Always Apply "THE YES SCAN" (check yourself, equipment and surroundings) prior to manoeuvring CTV.
