## Safety alert: Deck hatch closed on deckhand

### Depiction of incident

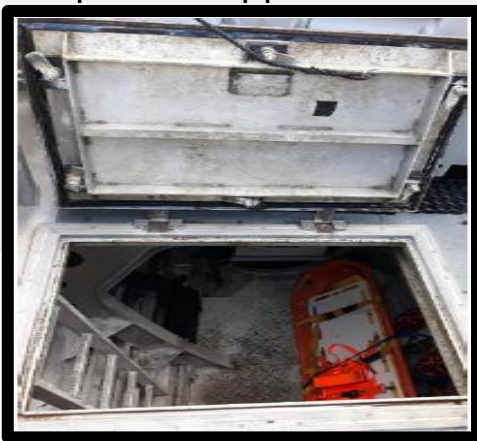
- During a CTV audit of rescue equipment on port, a deckhand was retrieving a stretcher from below deck.
- Whilst climbing out of the void space the hatch dropped and hit the deckhand on the forehead.
- The deckhand received first aid treatment on board the CTV and was then taken to A&E for further attention, where surgical glue and strips were applied to cut.

Open hatch

- Toolbox talk to be delivered to all crew regarding hatch safety secure hatches when working below
- Use the correct PPE for task
- Barriers around all open hatches at all times to highlight deck crew inside void and engine spaces.
- Conduct formal planning meeting before starting the days work and highlight associated risks.
- Review storage below deck (Can the equipment be stored above deck to reduce open hatch operations)

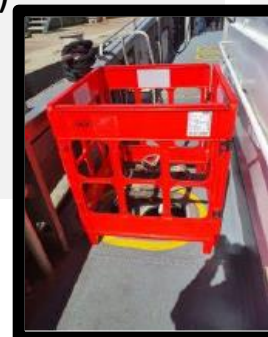
Barrier around open hatch
