Safety alert: Electric shock from damaged plug

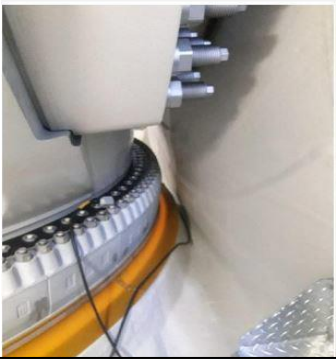
Cable and plug lying on the Yaw ring

- This plug lead has to pass through an opened hatch from nacelle to hub and then be withdrawn and hatches closed for blade pitch rotation. Excess cable has to be stored neatly to reduce trip hazards.
- In this instance, the excess cable and plug have found its way onto the nacelle yaw ring suffering damage to the plug housing.
- It is assumed that the technician pulled the cable back to gain access to the plug without visually checking the circuitry.

- Cables should be coiled and suspended from anchor points in the nacelle.
- Pre and post visual checks. Reminder in work briefs.
- Ensure plugs and cables are clear from crush, pinch points prior to yawing.
- Cable management mitigation measures to prevent cable coming into contact with yaw bolts and preventing entanglement – good house keeping.

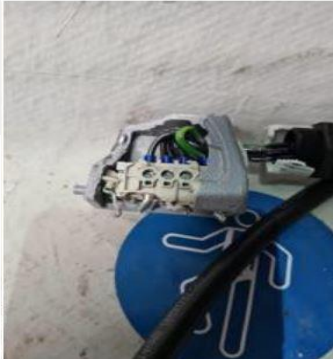
- When accessing nacelle to carry out required hub works prior to installation, a technician, took hold of the 230V plug intending to insert it in the hub power outlet socket.
- It was unnoticed that the plug casing had been broken and the circuitry exposed, the tech received a mild electric shock.
- Individual escorted back to vessel for examination.

Damaged plug
